**Friends of Garret Mountain Reservation  
Riparian Zone Restoration at Barbour's Pond  
Garret Mountain Reservation, Woodland Park, NJ**

**November 2, 2020**

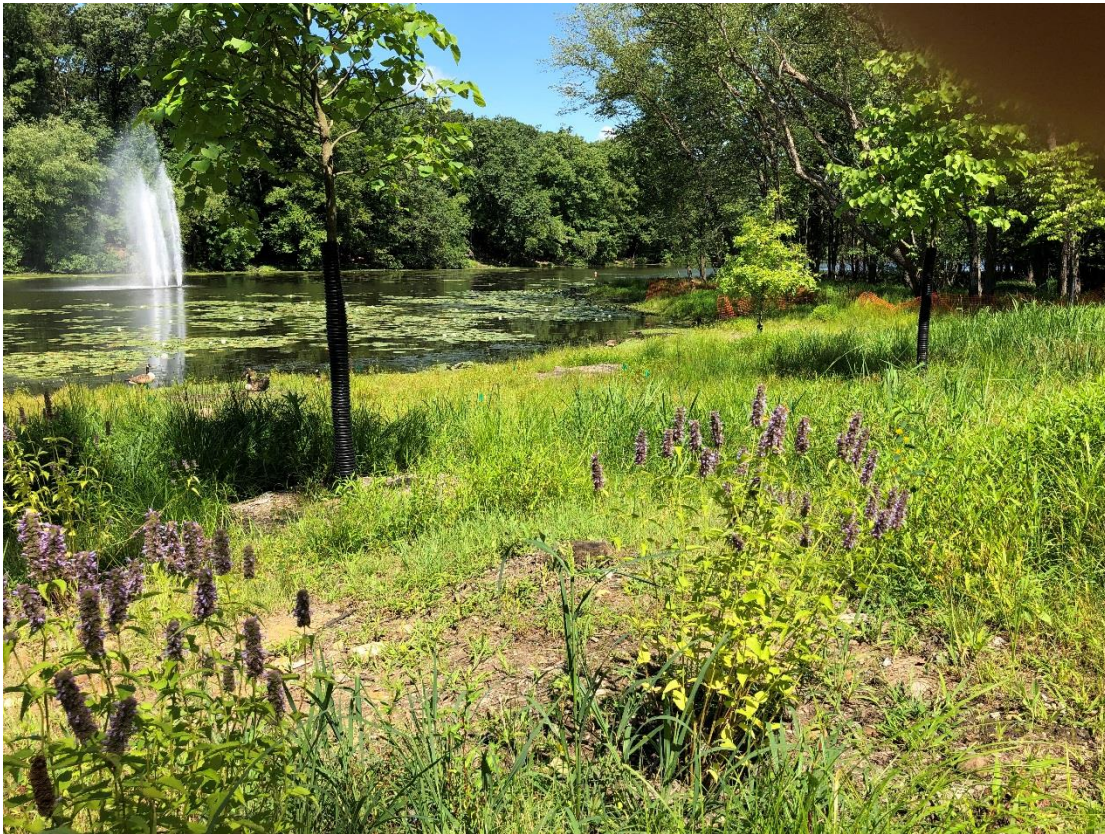
*Riparian Zone at Southeast corner of Barbour's Pond (Spring 2019)*

The Riparian Zone at the southeast end of Barbour's Pond (Garret Mountain Reservation) had suffered much damage during the dredging and construction work which took place during the winter of 2017-2018. Many trees had been removed, and the existing native vegetation was eliminated during the process. Following completion of the dredging work, nine trees (7 Redbud and 2 Pin Oak) were planted by the contractor. No additional planting or soil stabilization had been done by the dredging contractor, which resulted in erosion and sediment washing back into the pond. Meanwhile, the land which was once a lush forest and teeming with bird life, now lay barren and silent.

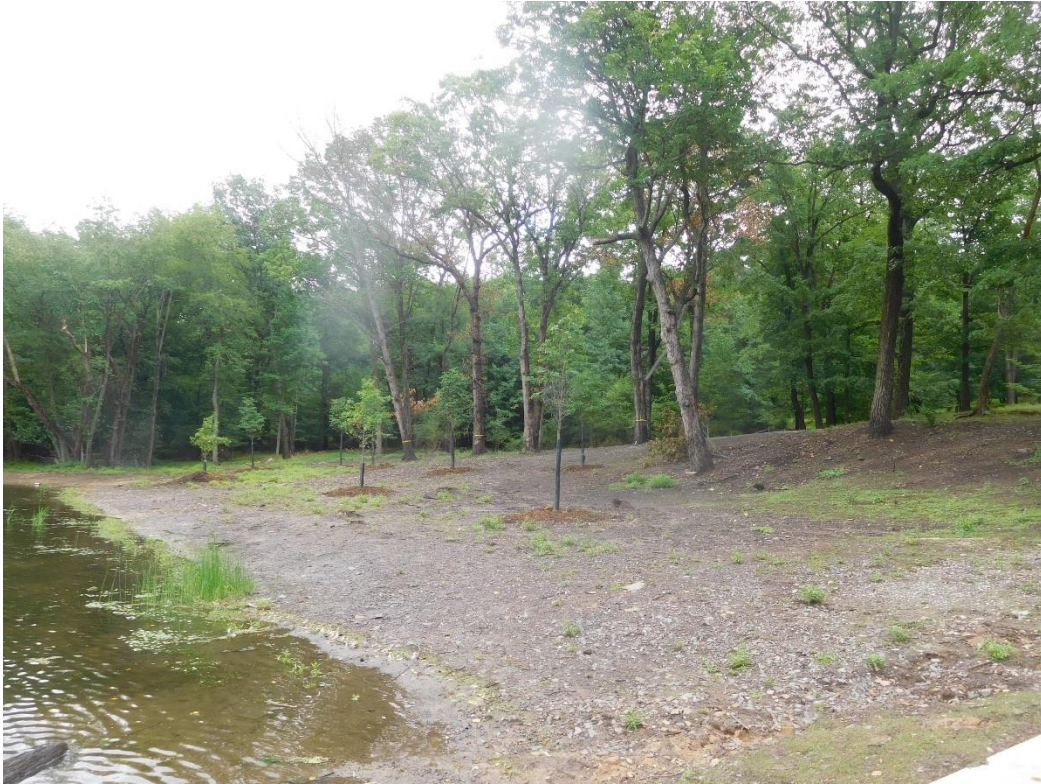
*July 2018*

**Before and After**
